DEPARTMENT OF TRANSPORTATION

Quality Assurance and Source Inspection

Contract #: 04-0120F4Cty: SF/ALA Rte: 80 PM: 13.2/13.9File #: 99.28**WELDING INSPECTION REPORT****Resident Engineer:**Siegenthaler, Peter**Address:** 333 Burma Road**City:** Oakland, CA 94607**Report No:** WIR-025371**Date Inspected:** 19-Jul-2011**Project Name:** SAS Superstructure**OSM Arrival Time:** 800**Prime Contractor:** American Bridge/Fluor Enterprises, a JV**OSM Departure Time:** 1630**Contractor:** Watson Bowman Acme Corp.**Location:** Buffalo, NY**CWI Name:** Greg Ross**CWI Present:** Yes No**Inspected CWI report:** Yes No N/A**Rod Oven in Use:** Yes No N/A**Electrode to specification:** Yes No N/A**Weld Procedures Followed:** Yes No N/A**Qualified Welders:** Yes No N/A**Verified Joint Fit-up:** Yes No N/A**Approved Drawings:** Yes No N/A**Approved WPS:** Yes No N/A**Delayed / Cancelled:** Yes No N/A**Bridge No:** 34-0006**Component:** Seismic Joint Hinge A**Summary of Items Observed:**

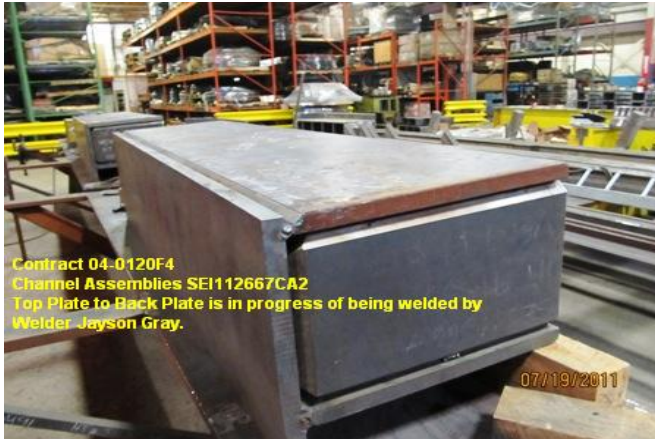
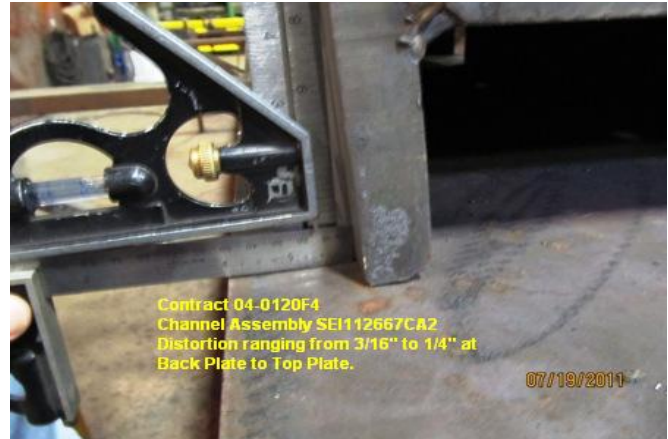
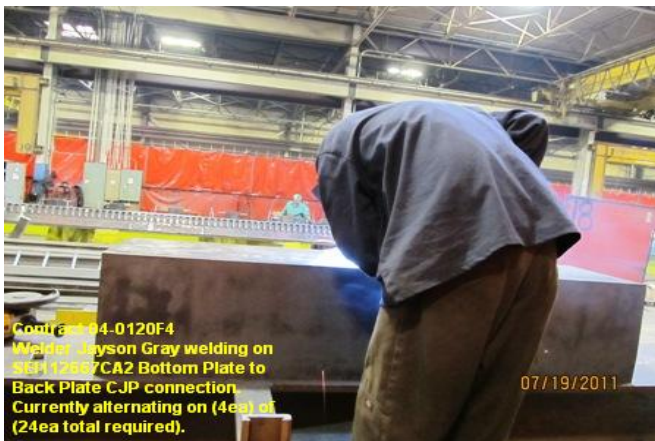
This (QAI) met with Watson Bowman Acme Corporation Quality Control Manager (QCM) Mr. Gregory Ross. This QAI observed certified welder Jayson Gray (welder ID#J) using the FCAW process (dual shield, 100%CO2), filler metal TM-811N1, to weld CJP welds on the SEI112667CA2 quantity of (4ea) of (24ea required) Channel Assemblies are being worked on at this time. Welds are being performed on the Bottom Plate to Back Plate connections. All welding was being performed in the 1G position. Dimensions were checked per SMR Bahjat Dagher request and flatness of bottom plate was verified to be acceptable at time of inspection. It was noted that 3/16" to 1/4" distortion exists within the Top Plate to Back Plate area. See attached photos.
